HIGH RELIABILITY SHEATHED, BERYLLIA INSULATED, TUNGSTEN-RHENIUM ALLOY THERMOCOUPLE ASSEMBLIES— THEIR FABRICATION AND EMF STABILITY

G. W. Burns, W. S. Hurst and M. G. Scroger

1. Report No. NASA CR-134549		2. Government Accession No.		3. Recipient's Catalog No.	
4. Title and Subtitle HIGH RELIABILITY SHEATHED, BERYLLIA INSULATED, TUNGSTEN-RHENIUM ALLOY THERMOCOUPLE ASSEMBLIES - THEIR FABRICATION AND EMF STABILITY				5. Report Date June, 1974

6. Performing Organization Code	
7. Author(s) G. W. Burns, W. S. Hurst, and M. G. Scroger				8. Performing Organization Report No. NBSIR 74-447	
9. Performing Organization Name and Address U. S. Department of Commerce National Bureau of Standards Institute for Basic Standards Washington, D. C. 20234				10. Work Unit No.

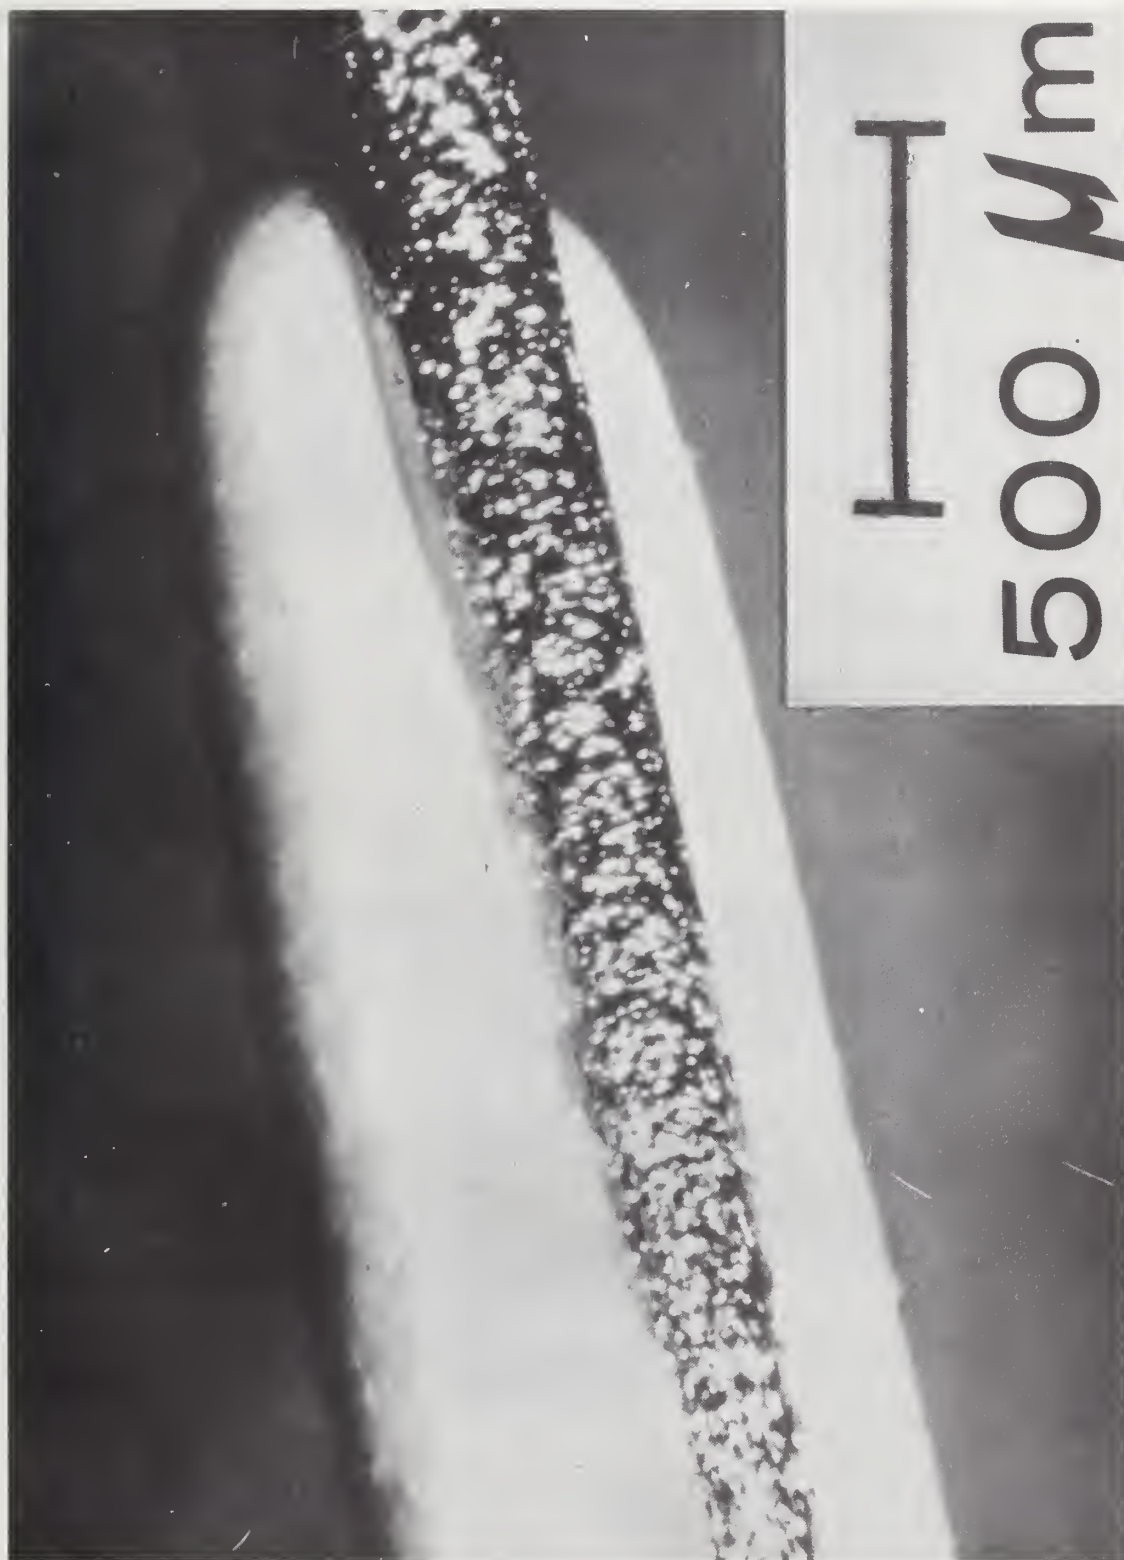
Figure 13. Photomicrograph showing the erosion of the BeO insulator near the measuring junction of an unsheathed thermocouple that was exposed within a tantalum blackbody enclosure for 307 hours at 2400 K in argon.

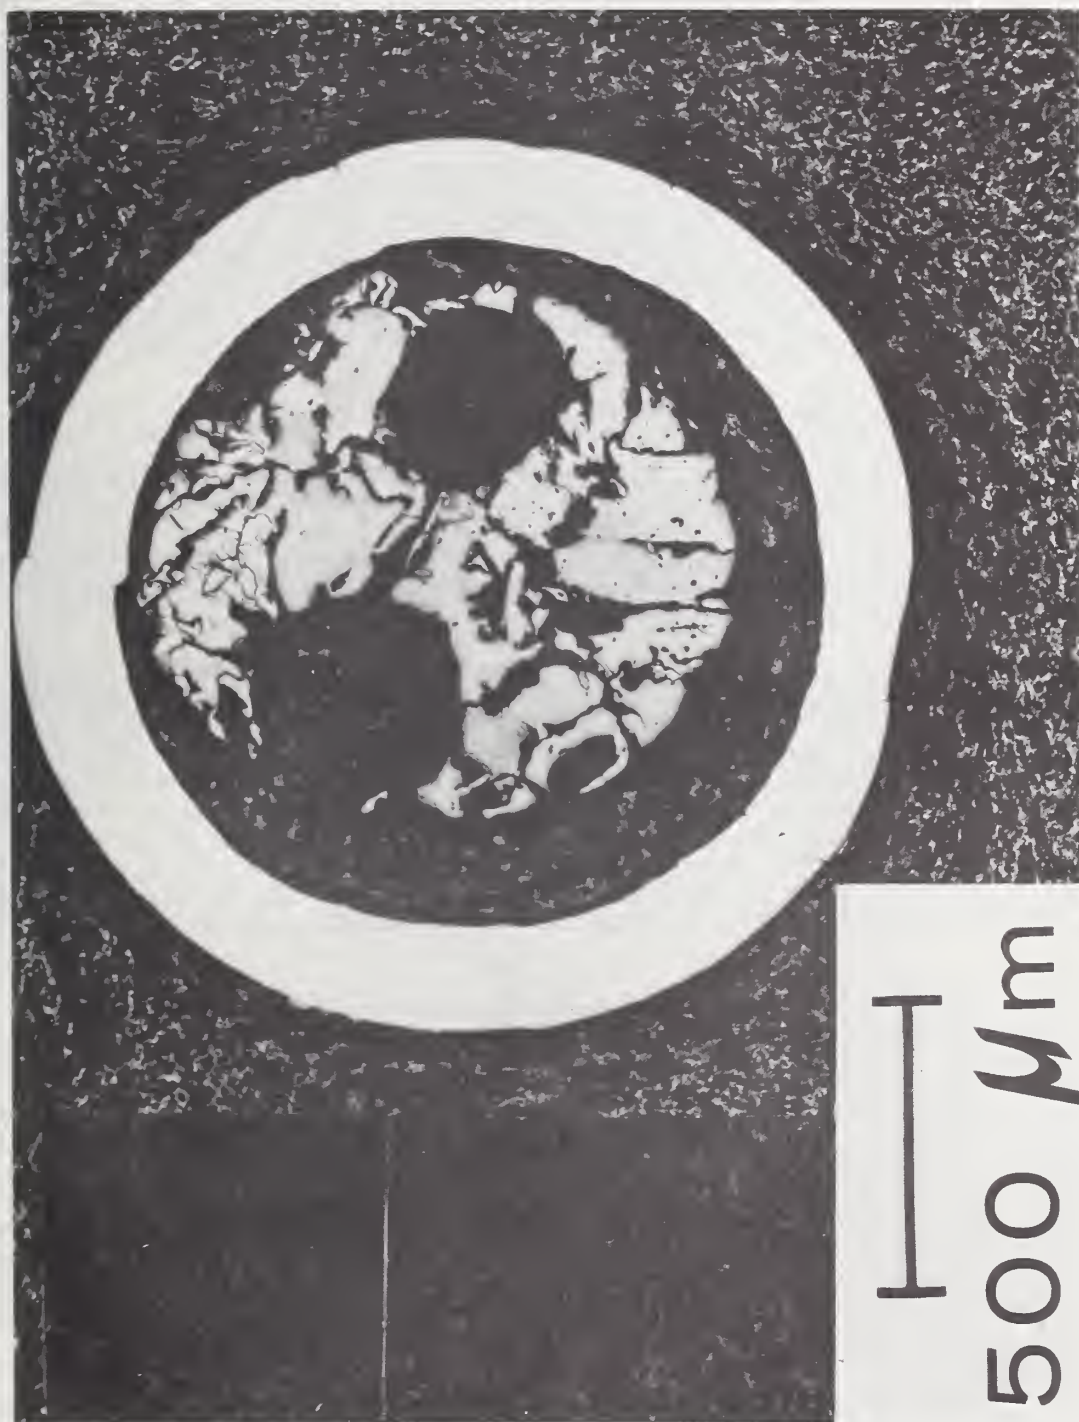
Figure 18. Photomicrograph showing a transverse cross-section of a BeO-Ta sheath assembly after exposure for 50 hours at 2400 K in argon. The cross-section was taken at about 4 cm below the open end of the sheath.
